NAVITAS – A Testbed for Integrated Daylighting and Electric Lighting Aspects

Largest low-energy building in Denmark provides good daylighting and allows for a detailed study of integrated electric lighting and solar shading

IEA SHC Task 61 Subtask D

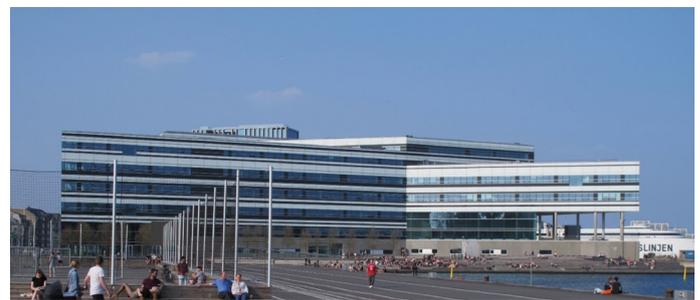
Figure 1. Navitas Building at Aarhus harbour front viewed from South.

Navitas (Fig. 1) is a centre for education, research and innovation addressing climate, environment and energy at the harbour front of the City of Aarhus housing up to 3,000 students, educators, researchers and innovators on a floor area of 38,000 m². Navitas was built between 2011 and 2014 as a joint venture between Aarhus University, INCUBA Science Park, and Aarhus School of Marine and Technical Engineering at a cost of ca. € 95 Million. The final design was chosen through a competition requiring a turnkey contract with integrated designer and contractor teams. The chosen design also had the most appealing daylighting. All spaces used for extended periods have daylight access through the façade or interior courtyards/atria (see also Fig. 4). The building is Denmark's largest low-energy commercial building and meets the stringent

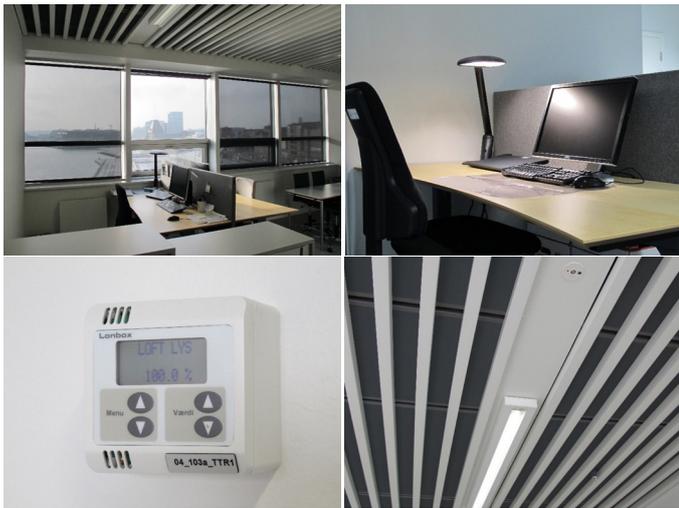
Figure 2. Lighting and solar control in typical office space (04.103) at Navitas.

reach 500 lux where required. Two luminaire circuits parallel to the window façade dim automatically according to available daylight levels via ceiling-mounted illuminance sensors and turn off completely when occupancy sensors no longer detect activity. Users can manually adjust the light output between 0% and 100% via a control panel at the entrance of each room. Shading consists of black, manually-operated, perforated interior roller blinds with 50% openings. These also serve for reducing light levels for media presentations during teaching.

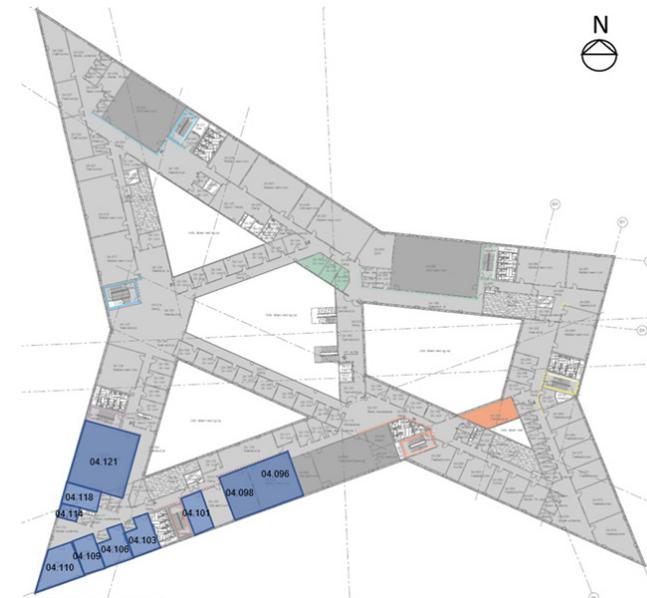
Figure 4. Fourth floor at Navitas with monitored spaces (blue).

Researchers from Aarhus University's Lighting Design Research Group established Navitas as a testbed for trialing established and novel ways of assessing integrated daylighting and electric lighting in the fall of 2019. A typical office space for academic staff (04.103) was fitted with various illuminance sensors, as well as two Raspberry-Pi computers with fisheye-lens cameras, whereas eight other offices and classroom spaces (fig. 4) were each fitted with

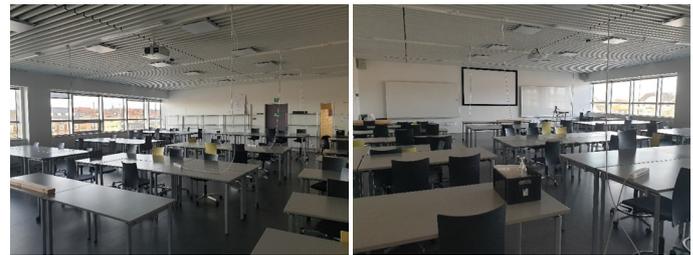
Figure 3. Typical classroom (04.121) at Navitas.

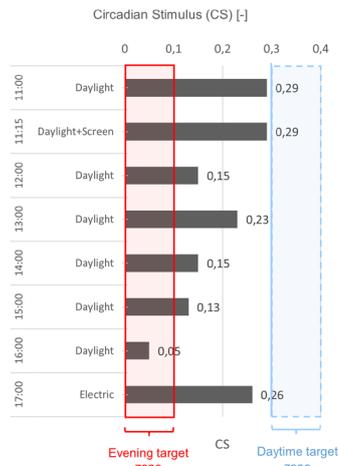
Figure 8. Circadian Stimulus (CS) calculated for a vertical illuminance at a height of 1.2 m above the floor in front of the computer screen. The target zones refer to the recommendations of the Lighting Research Center, Troy, NY.

lighting scenarios (fig. 7). The circadian potential expresses how a specific lighting scenario could support a building occupant's daily sleep/wake rhythm and well-being. This was evaluated using two metrics: the Melanopic Equivalent Daylight (D65) Illuminance (M-EDI) and the Circadian Stimulus (CS). Spectral power distributions (SPDs) were measured at workstations at a height of 1.2 meters at different times during the day. The results for on 21 January 2020 indicate CS values of between 0.05 and 0.26 for "daylight" and 0.26 for "electric lighting", and M-EDI values between 16.9 lux and 183.33 lux for "times with daylight" and 104.74 lux for "electric lighting" (figs. 8 and 9). For electric lighting alone, both CS (0.26) and M-EDI (104.74 lux) have been calculated as being too low for "ok" and "good" target zones. This suggests that occupants starting work during winter mornings will not receive sufficient circadian stimulus from the ceiling luminaires. Daylight at 11:00 does not fulfil the recommendations for the "good" target of 218 lux M-EDI, but reaches the "ok" target of 136 lux M-EDI. During the summer, the circadian stimulus at workstations near the window would be sufficient.
